## GEHC Custom Shuttle Power System – FW Update Package 15167 21 May 2021.

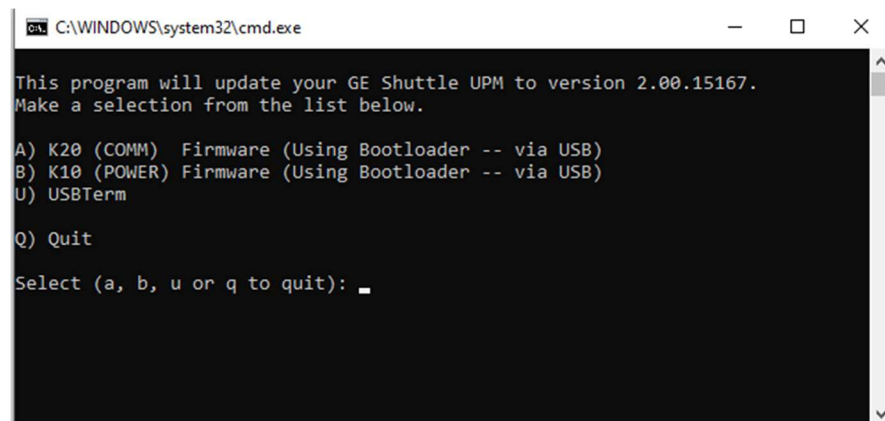
1. To begin, connect the UPM USB port to the computer USB port.  
*Note: UPM needs to be plugged into AC source with UPM turned on.*
2. Using Windows Explorer, double-click on the file icon for *upm-ge-15167.sfx-2.exe* executable in the folder it was copied to.
3. When prompted, click “yes” to allow Firmware Update application to make changes to the UPM. The following screen will appear.

```
C:\WINDOWS\system32\cmd.exe

This program will update your GE Shuttle UPM to version 2.00.15167.
Make a selection from the list below.

A) K20 (COMM) Firmware (Using Bootloader -- via USB)
B) K10 (POWER) Firmware (Using Bootloader -- via USB)
U) USBTerm

Q) Quit

Select (a, b, u or q to quit):
```

Select option A..
